NATIONAL PROGRAM FOR INSPECTION OF NON-FEDERAL DAMS
WHITNEY DAM (CT 00477) (U) CORPS OF ENGINEERS WALTHAM
MA NEW ENGLAND DIV DEC 80

THAMES RIVER BASIN
STAFFORD, CONNECTICUT

WHITNEY DAM
CT 00477

**PHASE I INSPECTION REPORT
NATIONAL DAM INSPECTION REPORT**

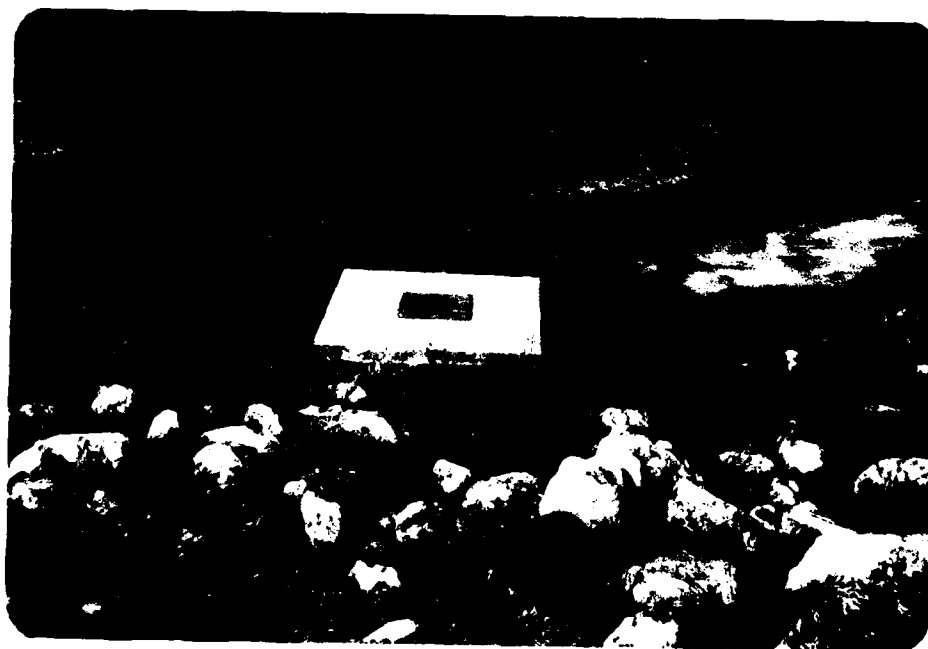
C-8 PRINCIPAL SPILLWAY INLET RISER

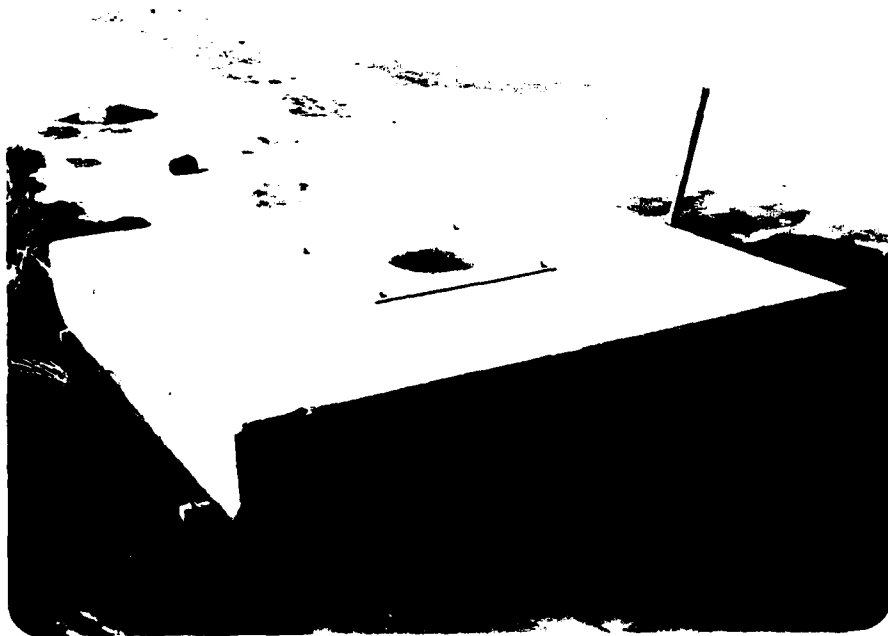
C-9 PRINCIPAL SPILLWAY INLET RISER

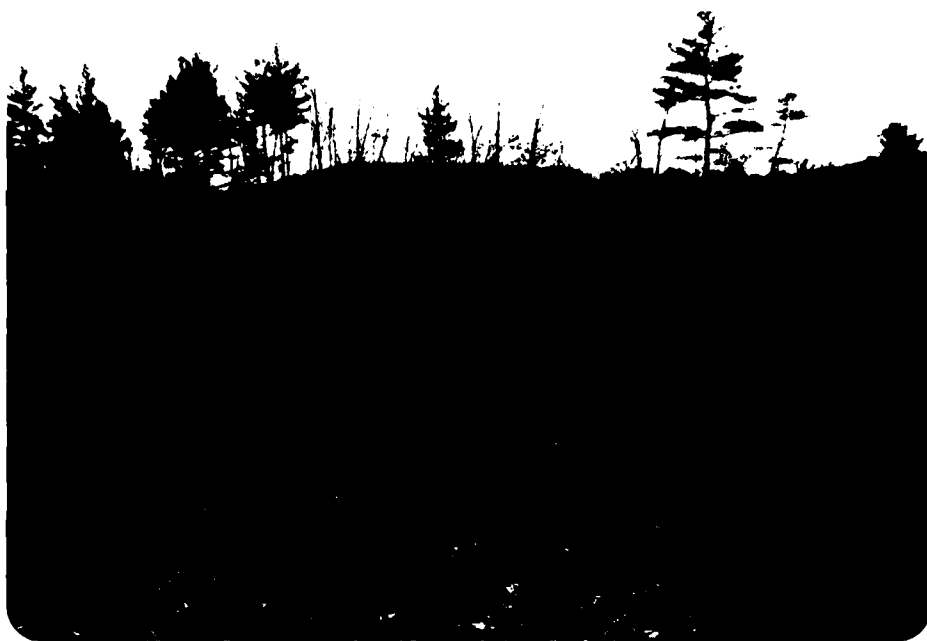
emergency spillway. The spillway is in good condition with very little chance of erosion due to the underlying bedrock.

C-11 EMERGENCY SPILLWAY LOOKING DOWNSTREAM

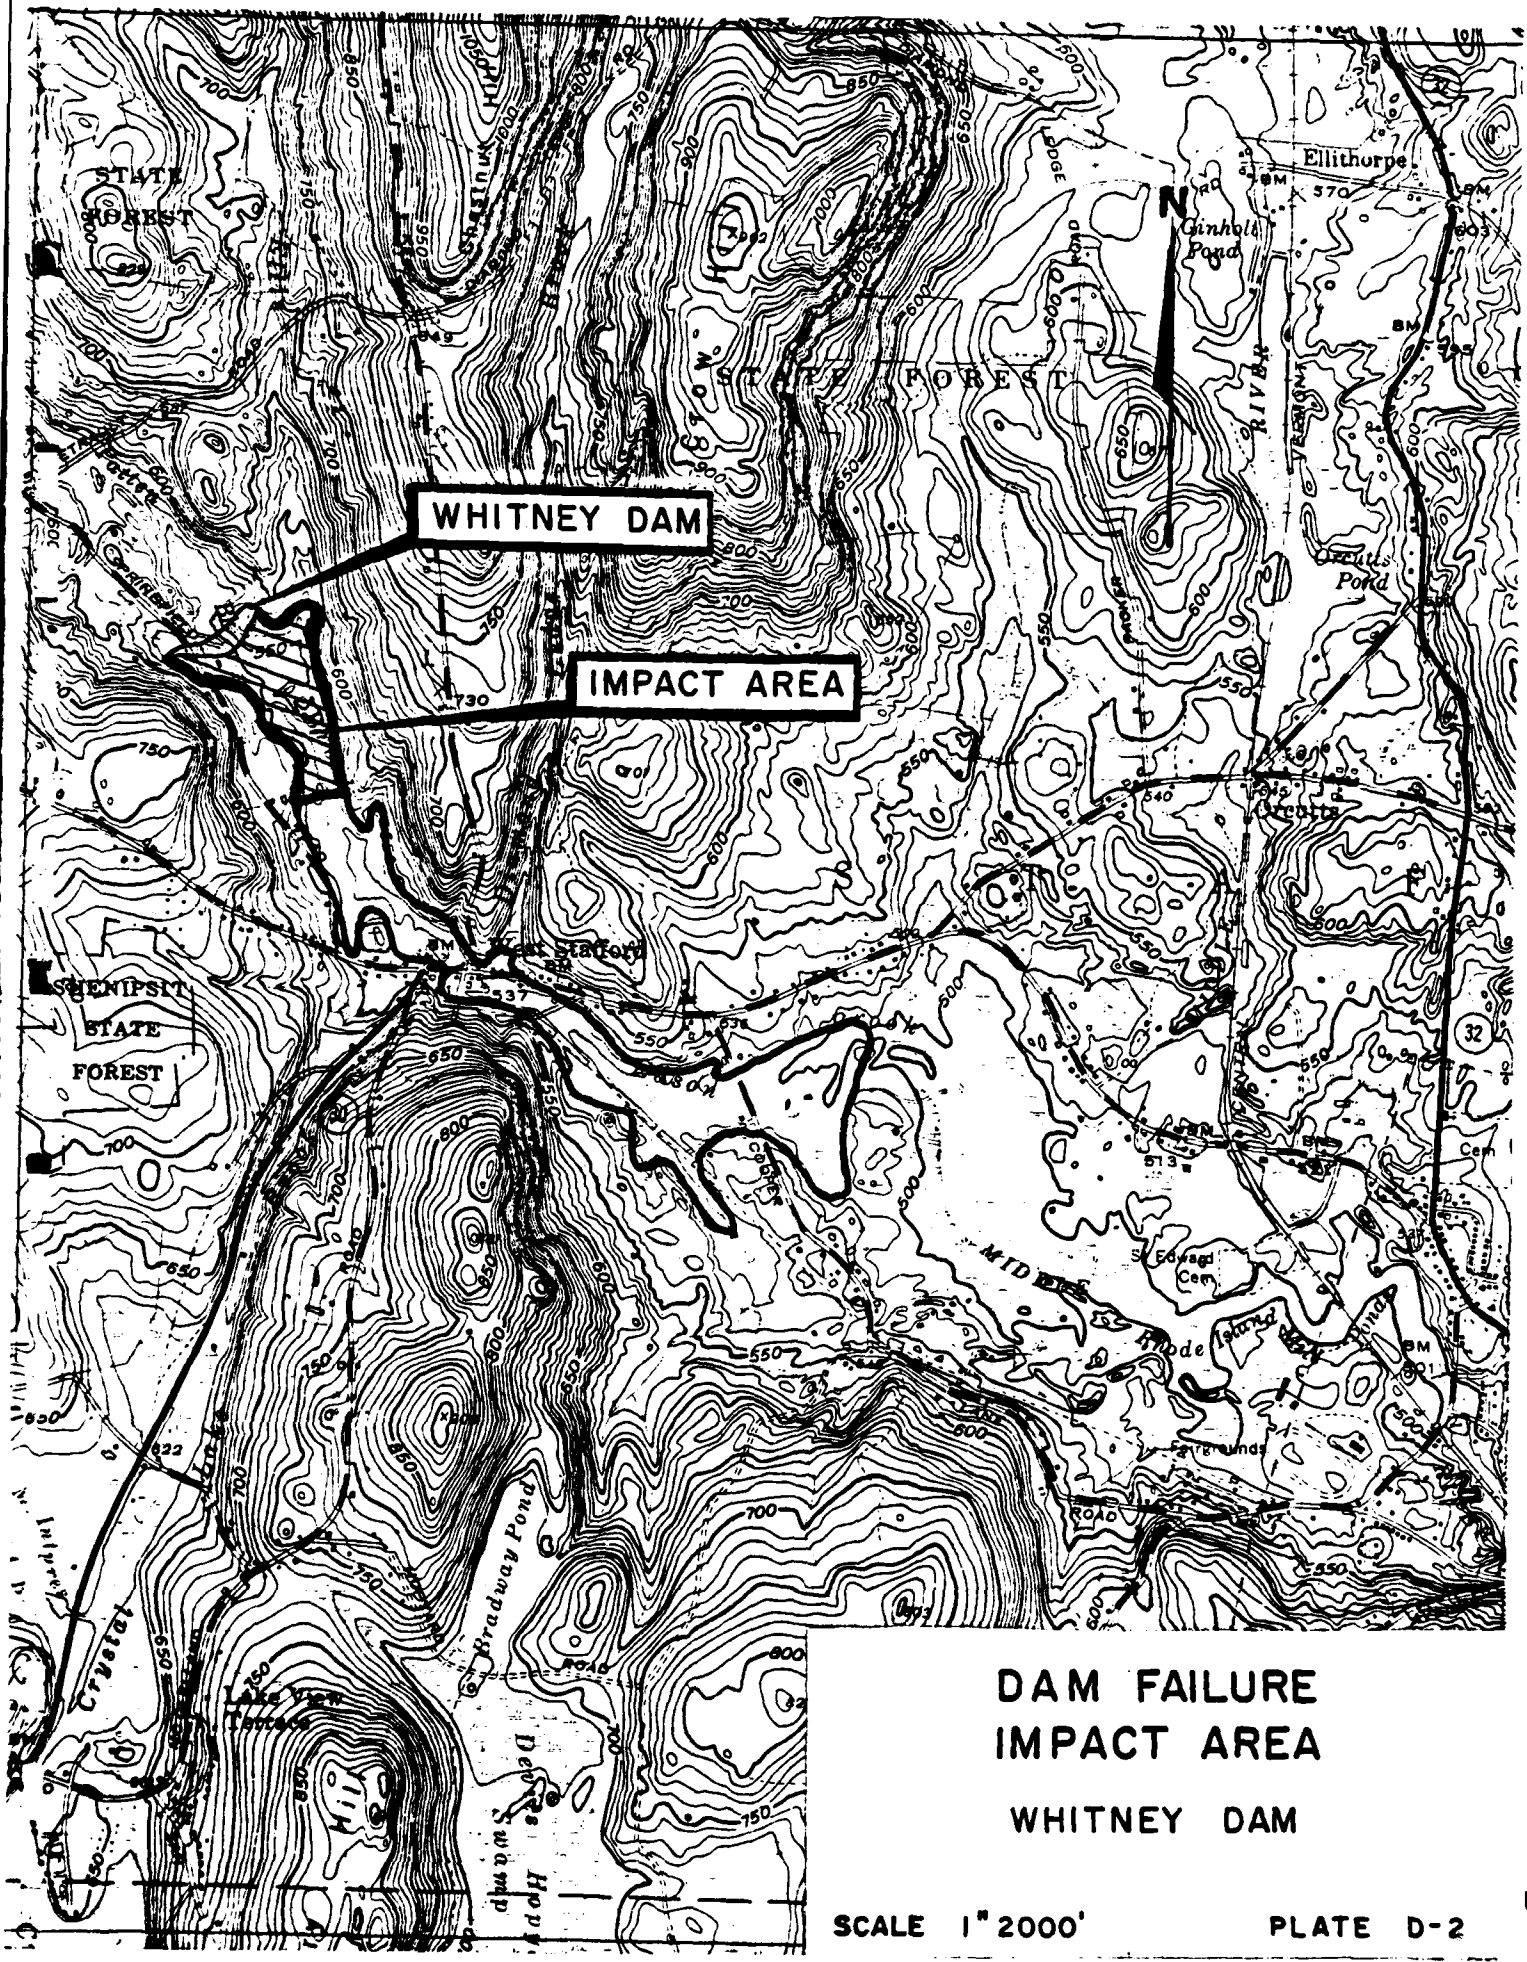
PLATE D-2

Applying the calculated dam failure discharge of 160,400 cfs. when the impounded water level in the reservoir is at elevation 594.5 (Test Flood Surge) will produce an approximate water surface elevation of 585 just downstream of the dam. At the peak discharge rate of 1,930 cfs for the test flood, the approximate water surface elevation would be 552 just downstream of the dam. The depths of flow would range from 40.5 feet at the dam to 20.2 feet approximately 2,000 feet downstream.

From 500 feet to 2000 feet downstream of the dam, a private swim club maintains several facilities including areas for camping vehicles. The following table shows the pre and post-failure water elevations along with the increased depth of water due to the assumed failure in the area where campers could be located:

These increases in water elevations could cause the loss of more than a few lives which establishes the hazard classification as HIGH. Therefore, water depths at specific structures downstream of this area were not determined.

**DAM FAILURE
IMPACT AREA
WHITNEY DAM**
